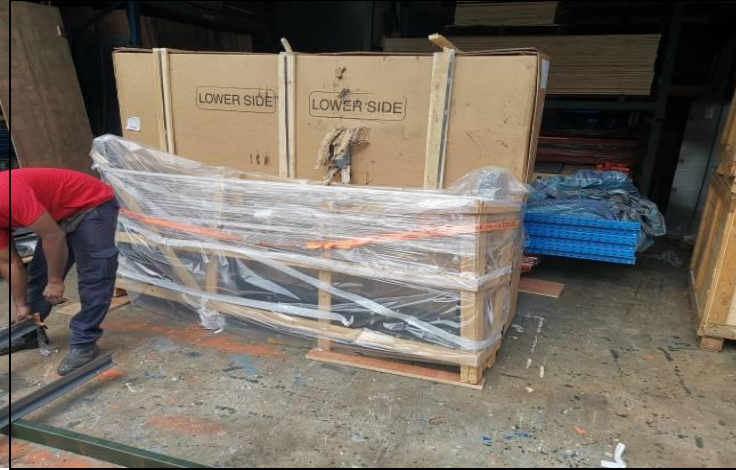
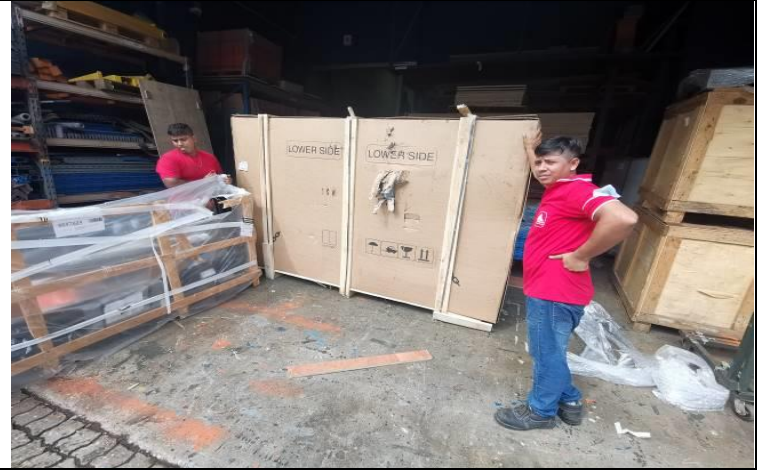
The open wooden crate attached to the side of the corrugated cardboard package was removed and not surveyed.

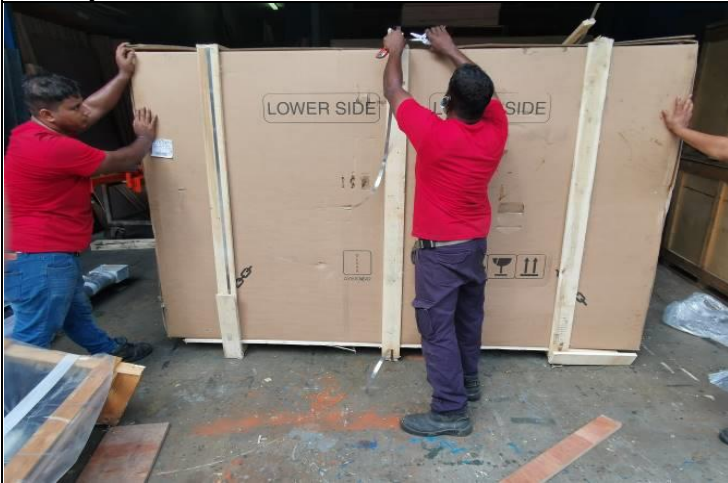
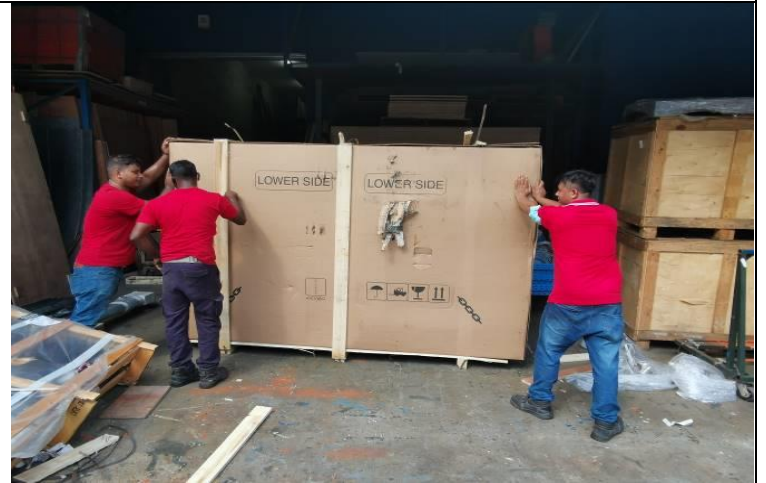
The wooden frames and metal cables were removed in order to check the contents within the corrugated cardboard package.

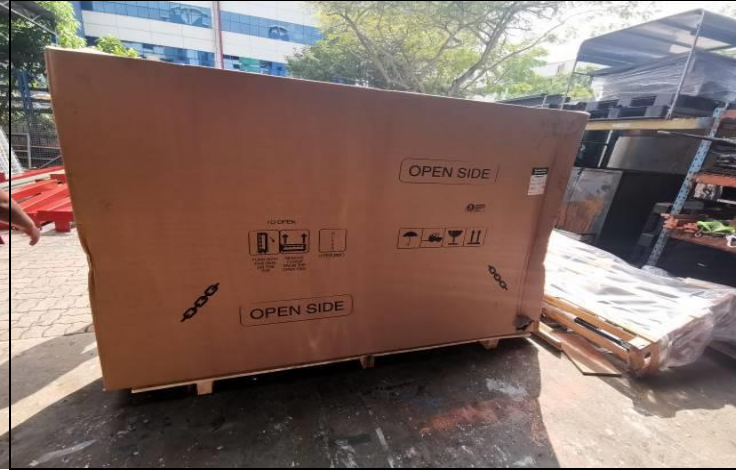
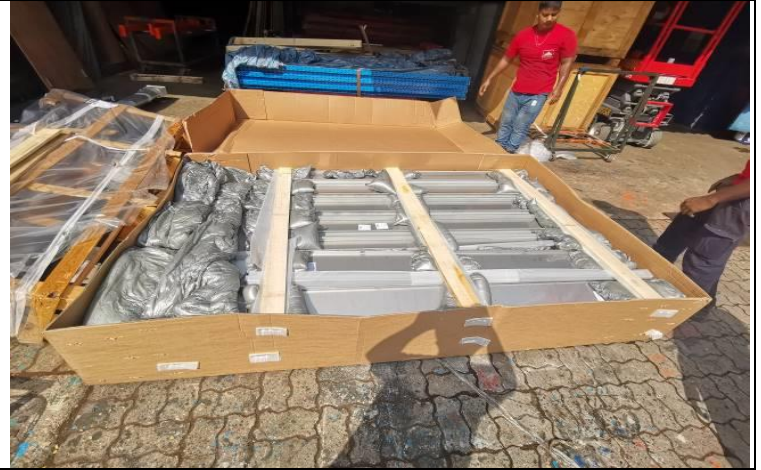
The contents within the corrugated cardboard package

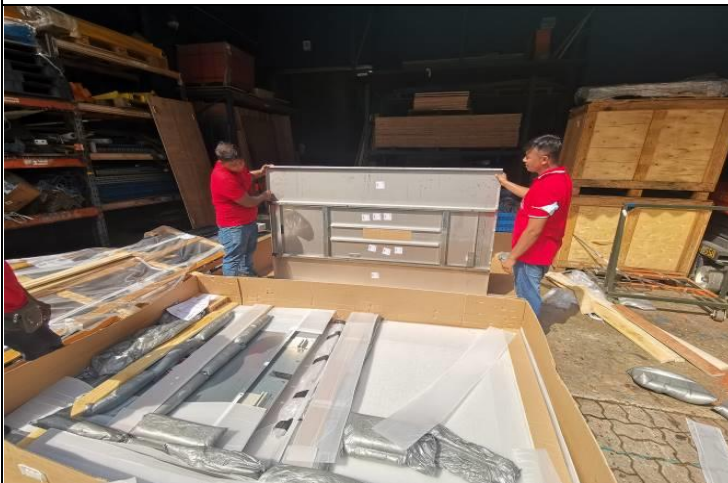
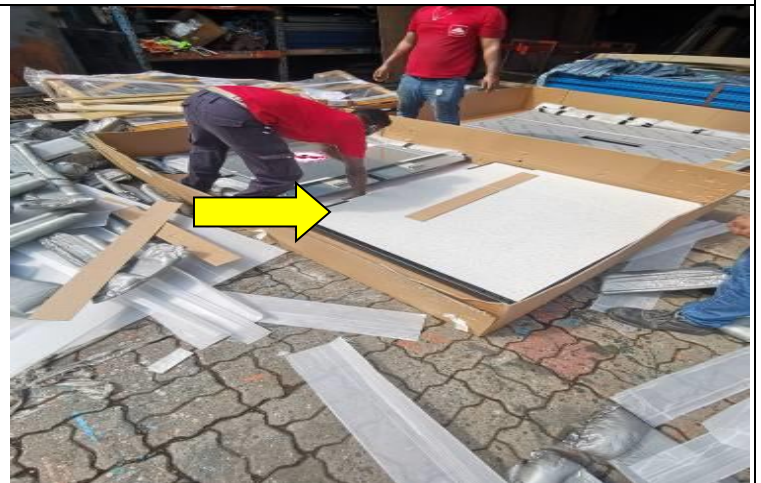
The staff of Consignee checking through the contents. The platform of the elevator as per 'Yellow Arrow'.

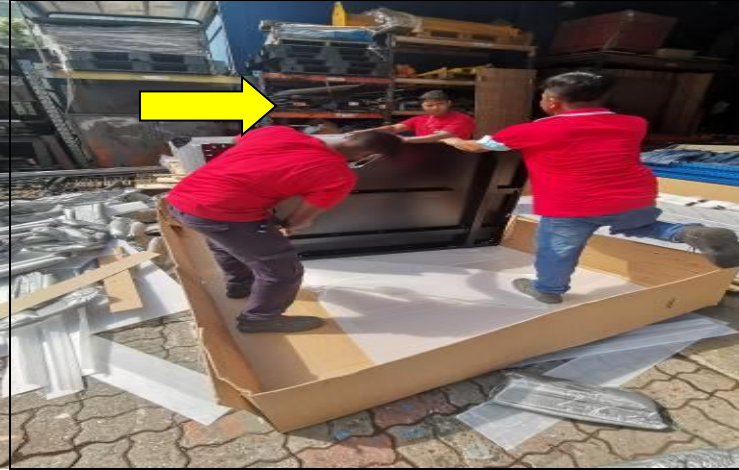
PHOTO 13

The underneath of the elevator's platform as per 'Yellow Arrow'

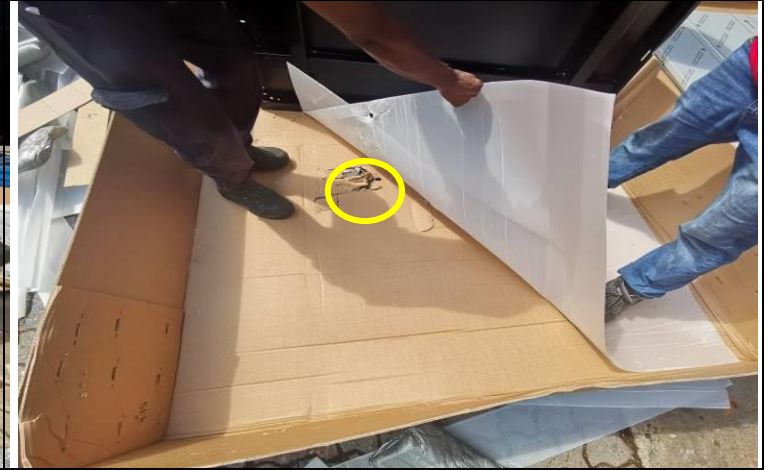
PHOTO 14

The plastic sheet was in between the platform of the elevator and the torn opened hole of the package

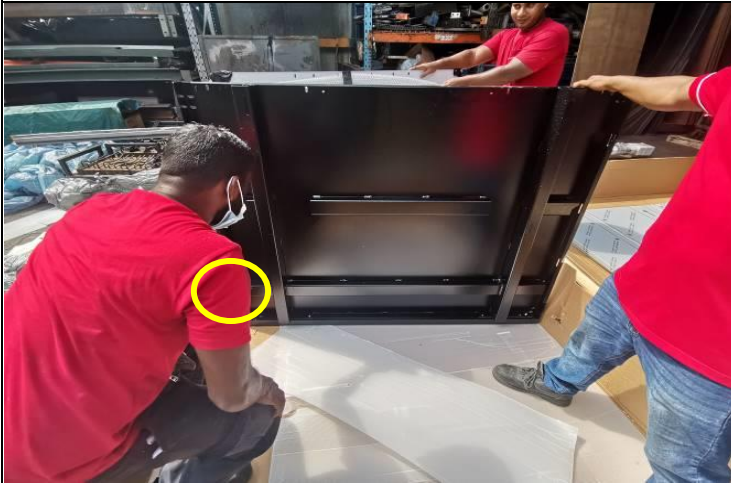
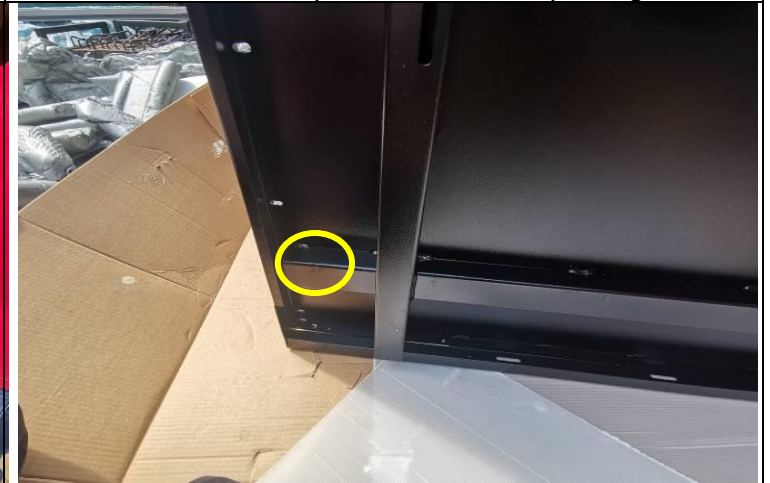
There was a scratch mark on the underneath of the elevator's platform as per 'Yellow Circles'

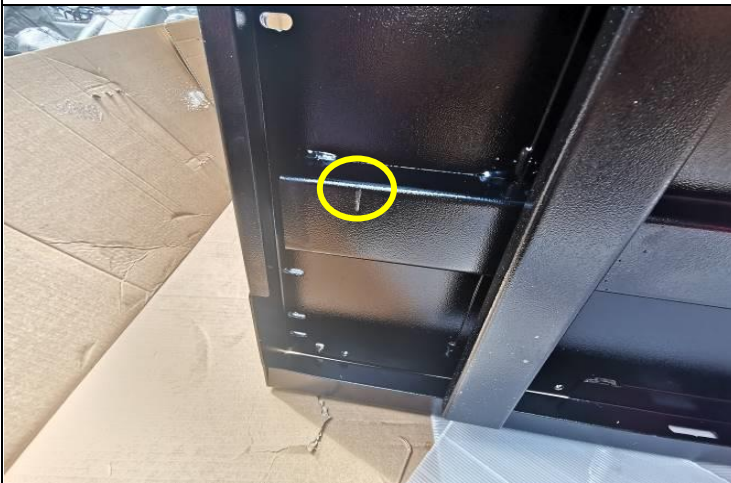
PHOTO 17

Close up view of Photo 16

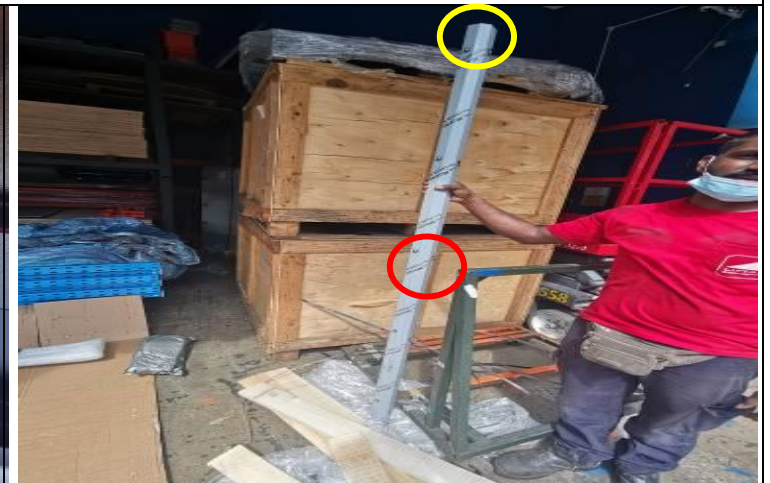
PHOTO 18

The support beam of the elevator found with scratch marks as per 'Yellow & Red Circles'

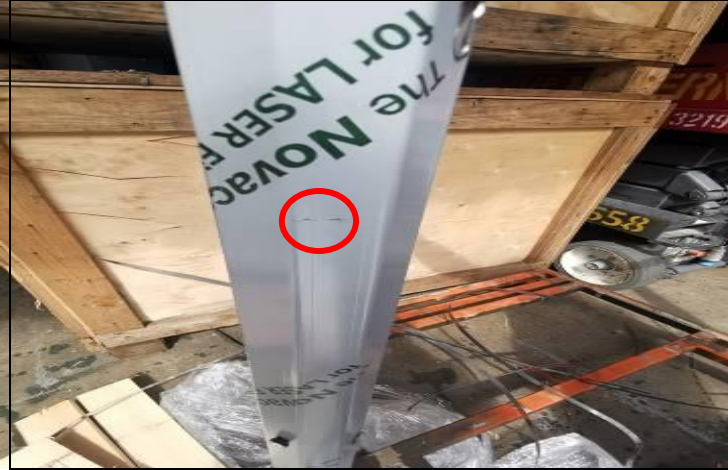
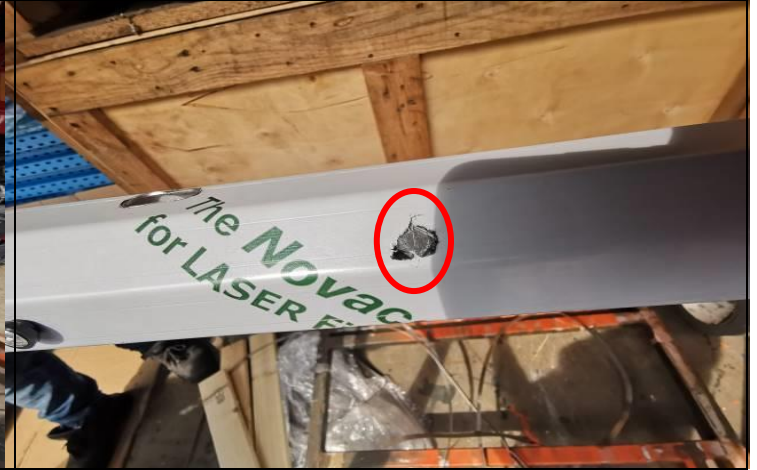
The support beam of the elevator found with scratch marks as per 'Red Circle'

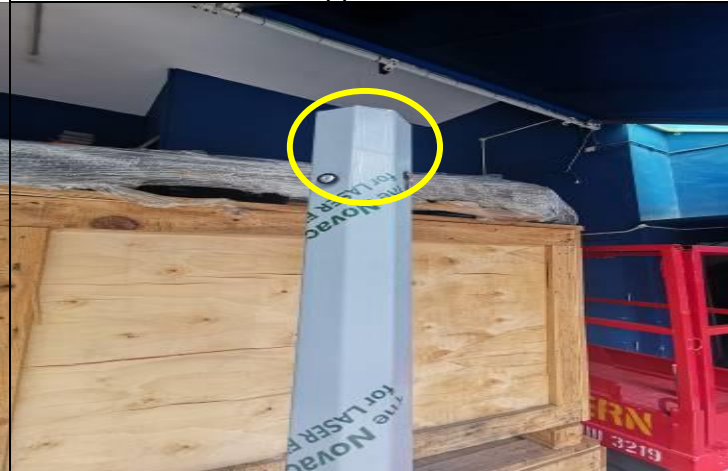
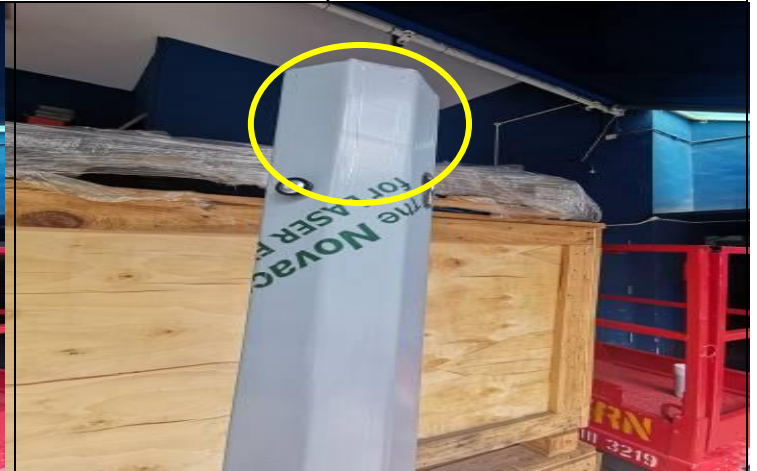
The support beam of the elevator found with scratch marks as per 'Yellow Circle'
